# Virtual Case for IMDRF Adverse Event Terminology Training

**Case serial: SCH-2024-01-01**

**Title: Silicon Levin tube, 14FR**

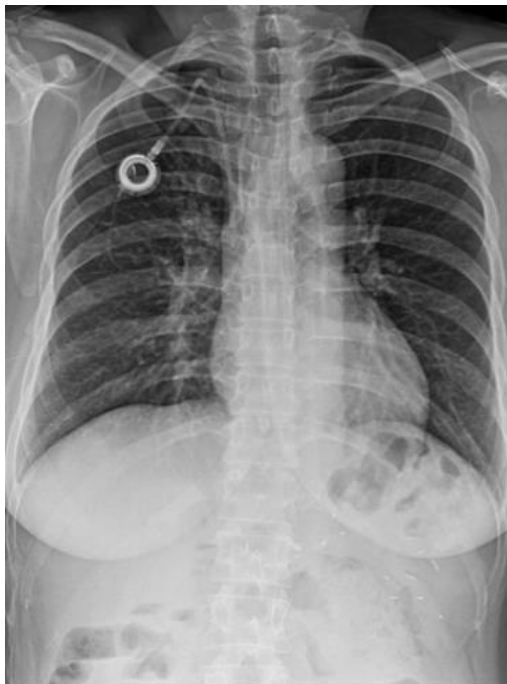
- The radiologist failed to find the Levin tube from the patient's chest X-ray image. Refer to Figure (a). Normally, the Levin tube would be observed in the chest X-ray image as shown in Figure (b).

(a) Patient's chest X-ray; failed to find Levin tube

- Removed the Levin tube for patient safety and inserted another 14Fr tube.
- The patient retook a chest X-ray to check for the right placement of the Levin tube.
- The patient expressed discomfort in the nose area due to repeated insertion.

- Quality manager of the manufacturer detected that the radio-opaque line impregnated was narrower in width and contained smaller amount of barium sulfate at the tip, compared to the Levin tube of the same lot.
- The manufacturer decided to increase the width of the radio-opaque line to 8 mm for the Levin tube.
